[806 Paseo de Las Golondrinas. Bernalillo, NM](#)

REINSPECTION and DRAIN REPAIR Report – September 15, 2009

806 Paseo de Las Golondrinas. Bernalillo, NM

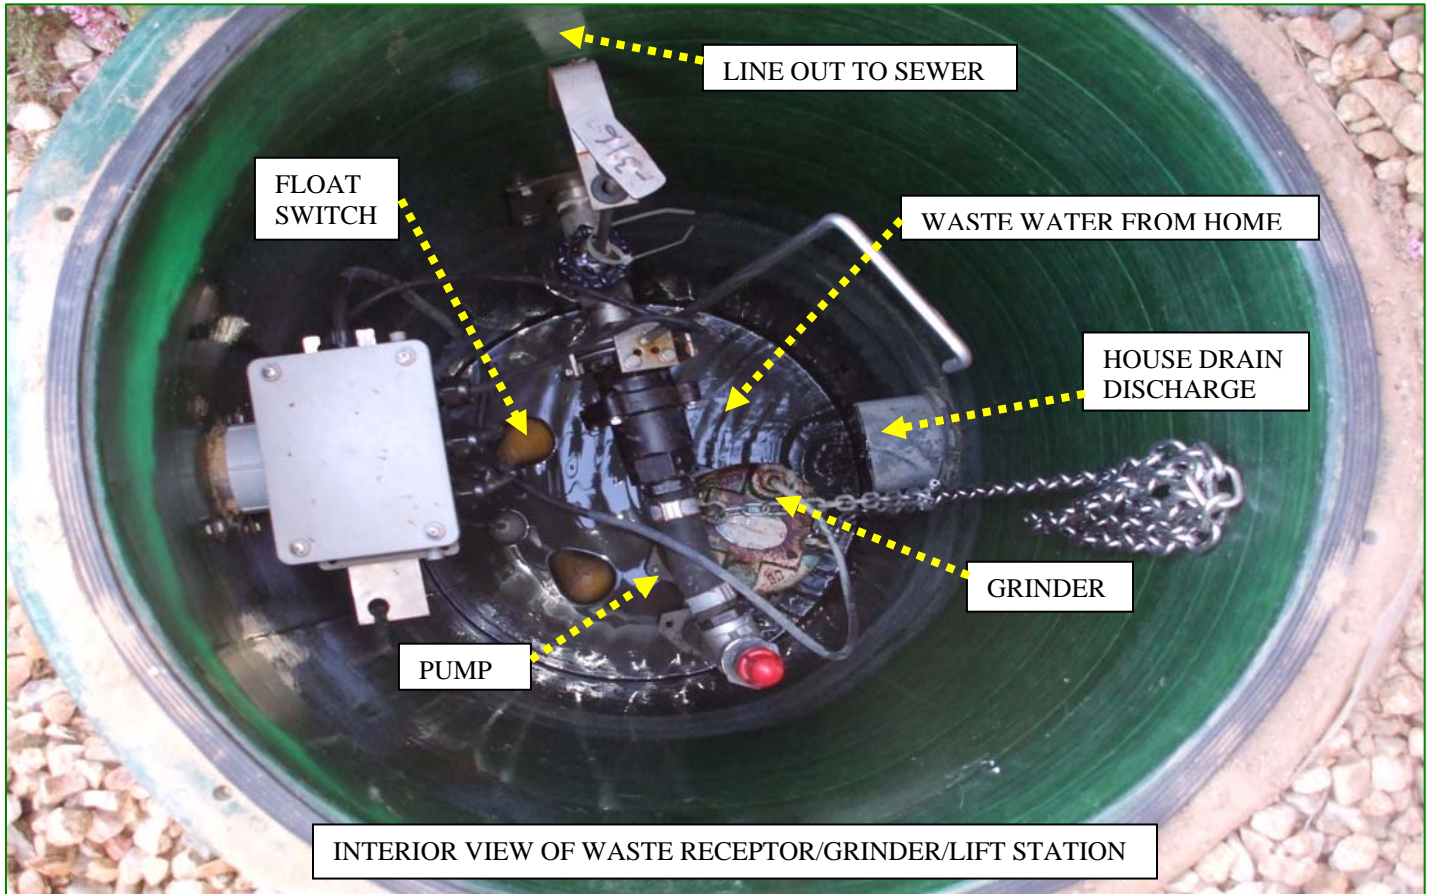
PLUMBING – The MBR bath Jacuzzi cold supply valve leaks. Standing water was observed per previous report The Drain problem has been cleared (as per this report). All of the other parts of the plumbing System seemed OK. (See images)
